1. INTRODUCTION

1.1 Overview of Mir Photo/TV Survey

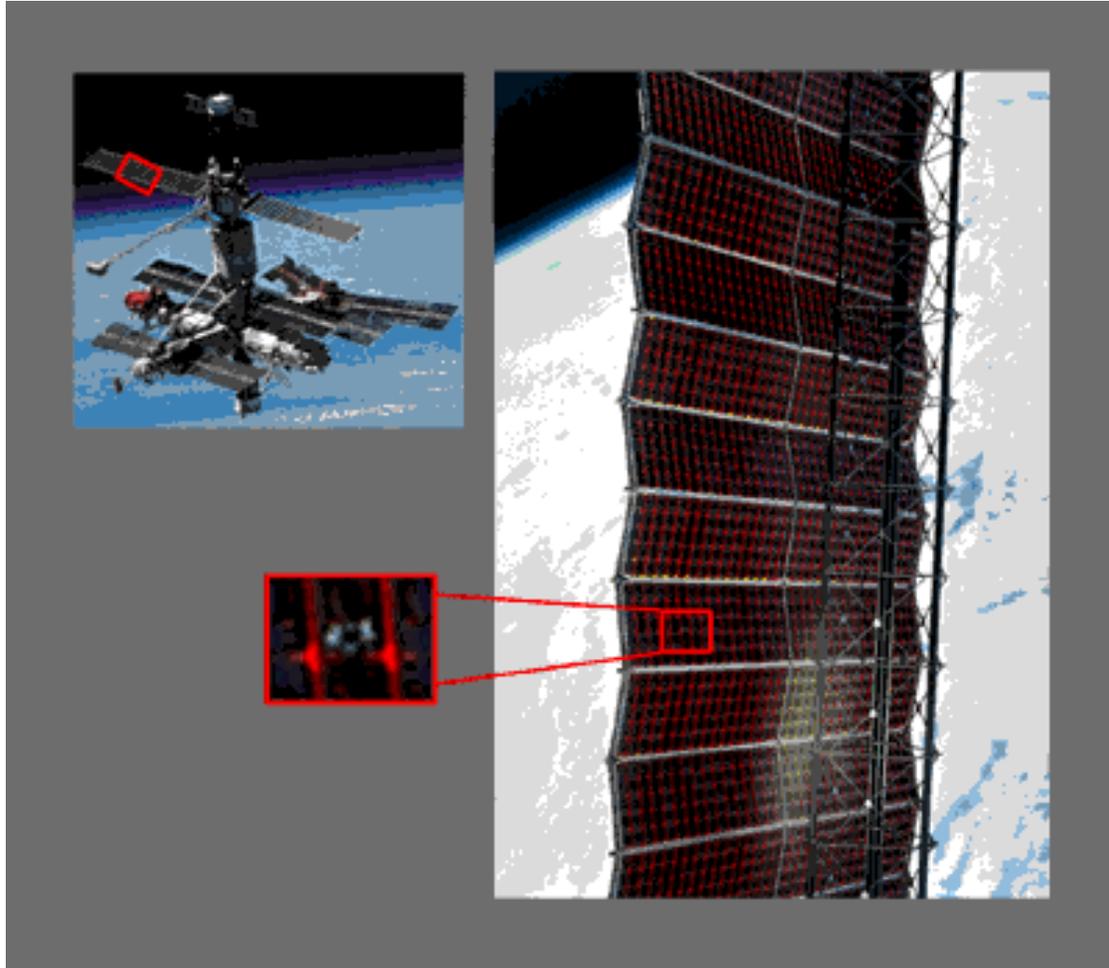
Figure 3-A Cooperative Solar Array

Figure 3-A is an image of the back surface of the CSA which is mounted on the -ZB axis of Kvant.

The enlarged area shows a region of a solar cell which is lighter in color than the rest of the cell. This anomaly covers the lower quarter of a single solar cell and may be caused by a micrometeoroid / orbital debris strike. However, a comparison of the histograms from the region in question with a region of the surface of the Earth does not suggest that there is a hole through the array.

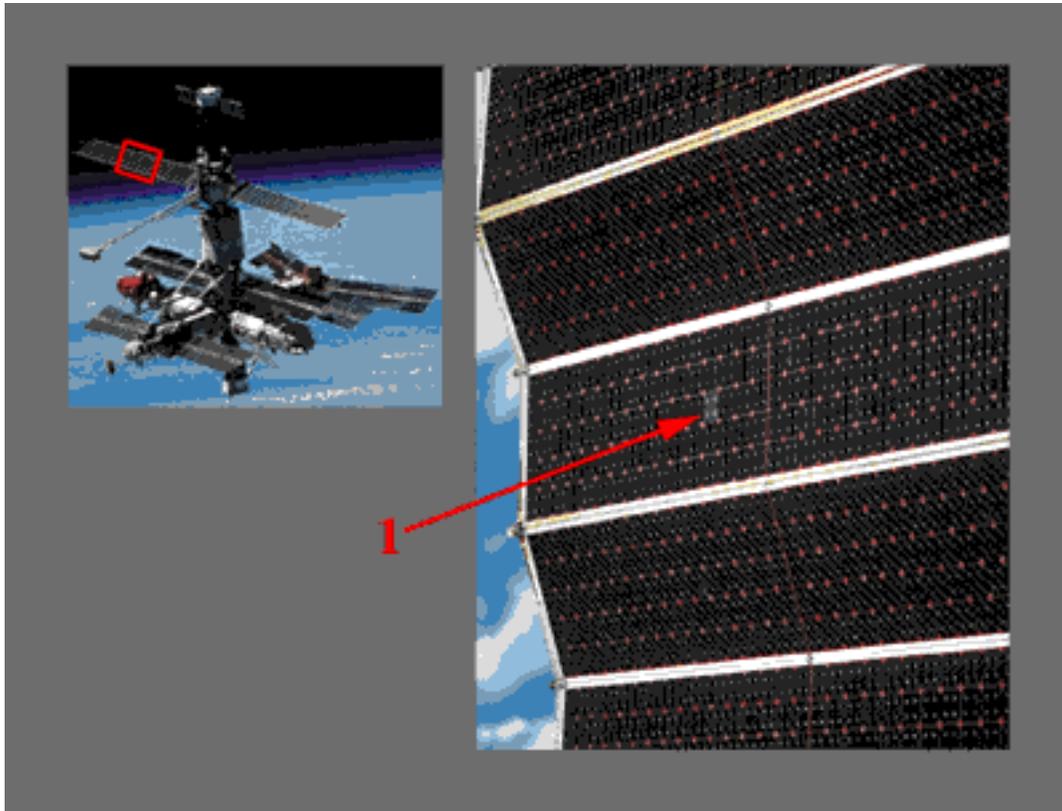
Figure 3-B Cooperative Solar Array

Item 1 points to a square region of the array that is lighter in color than the rest of the array. This area makes up one solar cell and the cause of the color difference in this cell is unknown.

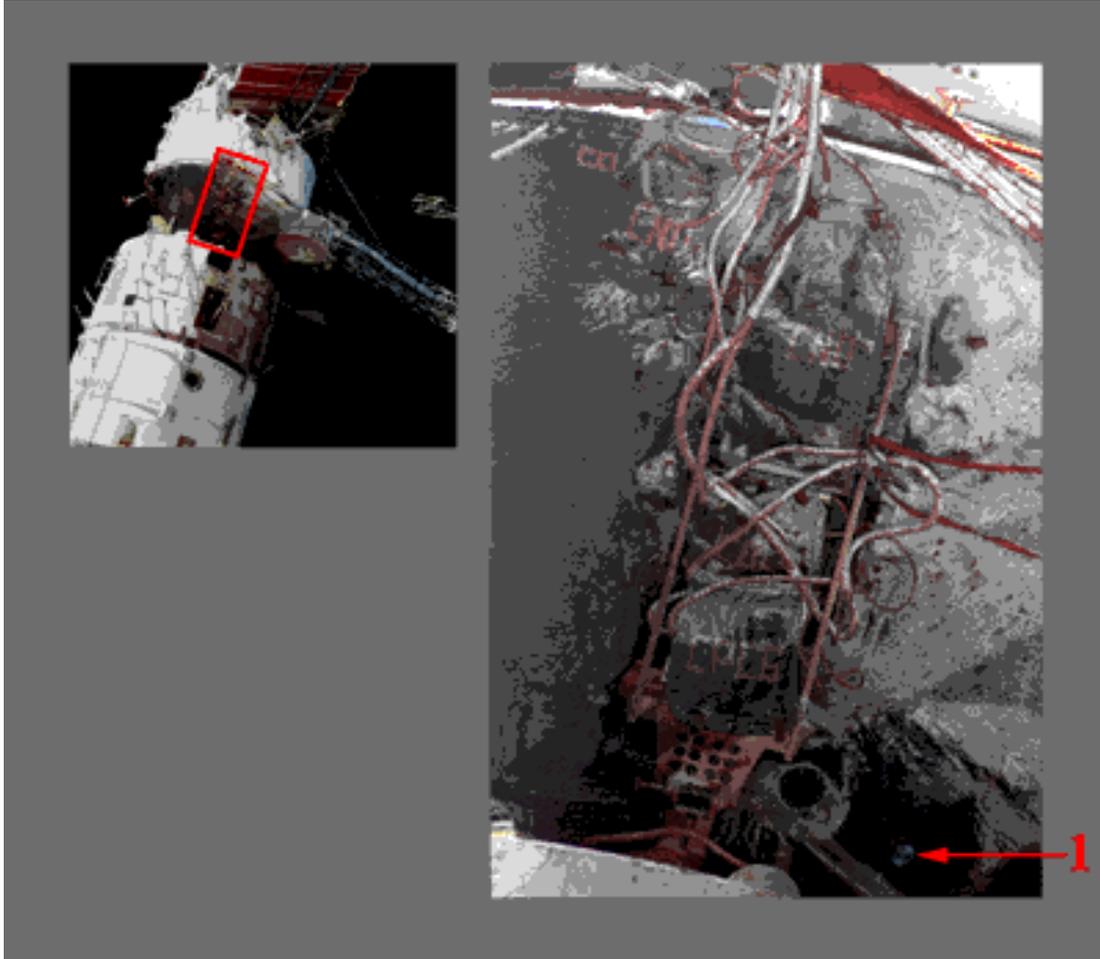
Figure 3-C Kvant End Dome

Detailed photography of the Kvant end dome provides valuable information on surfaces which appear to be blackened from contamination, while other areas appear relatively free of contamination. Photography of the front face of the Luch antenna dish clearly illustrates the extent of discoloration on the surface, which may be caused by the same contamination which has been deposited on the Kvant end dome.

Discoloration has been observed around the end dome of Kvant since STS-63. However, this photograph, taken with a 300 mm lens on the Nikon, reveals detail around the end dome which has not been seen previously. The image provides valuable information about the contamination which has darkened one area of the end dome while leaving other areas almost unaffected. Regions of the thermal blanket which are in line with the source of the contaminate and adjacent to features protruding from the surface of the module appear to be protected. The purge port which may be ejecting the contaminate is seen in Item 1. In addition, the various cables which run from the end dome of Kvant to the Sofora Thruster package at the end of the Sofora Truss are seen in the center of this image.

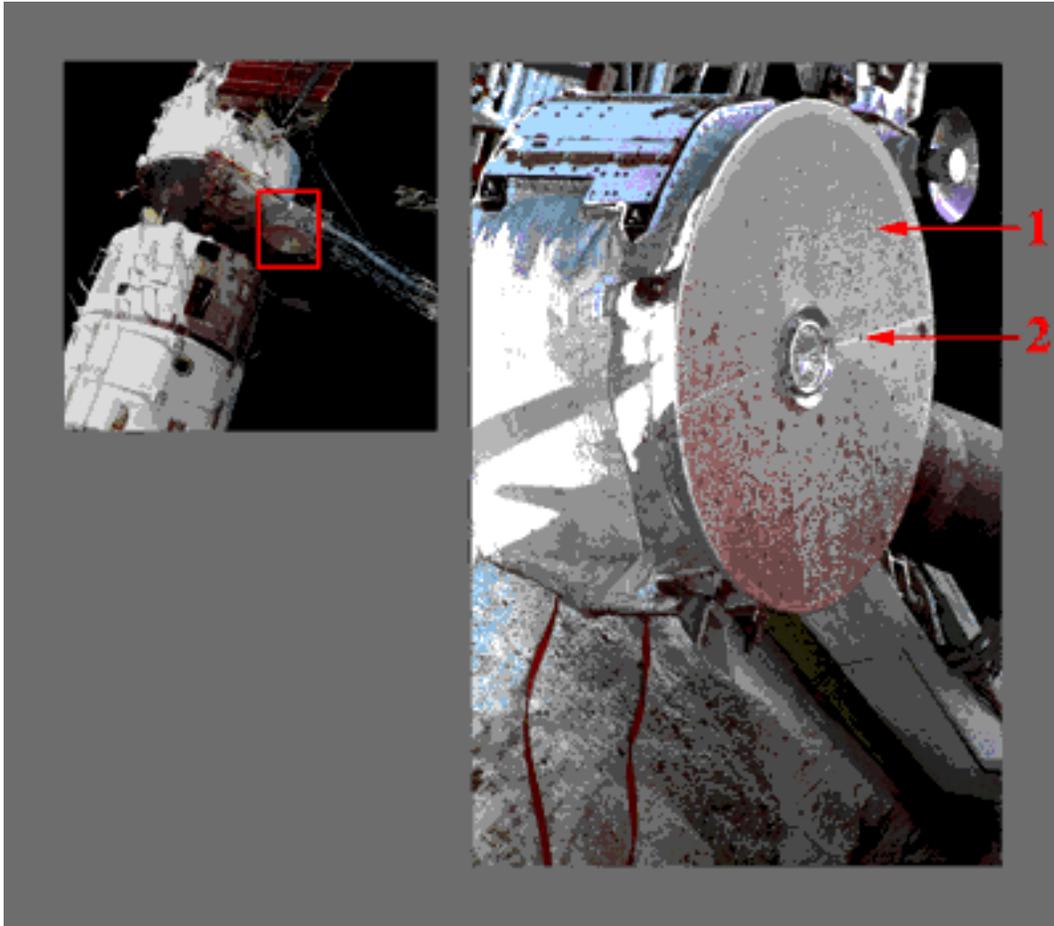
Figure 3-D Luch Antenna Dish

Figure 3-D shows the front face of the Luch antenna dish and clearly illustrates the extent of spotty discoloration on the surface. In the STS-76 mission report (JSC-27525), images of the dish from STS-63 and STS-76 were compared. A detailed examination indicated that the pattern of discoloration was very similar between the two missions. A comparison between those images and the detailed image from STS-79 reveal that the pattern of discoloration appears very similar across all three missions. This indicates that the phenomena which caused most of the visible discoloration occurred prior to STS-63 and that no significant changes have occurred since. The high degree of detail in the STS-79 image reveals two almost circular rings of dots which appear to actually be a component of the dish itself. These rings are pointed out as Items 1 and 2 in the figure.

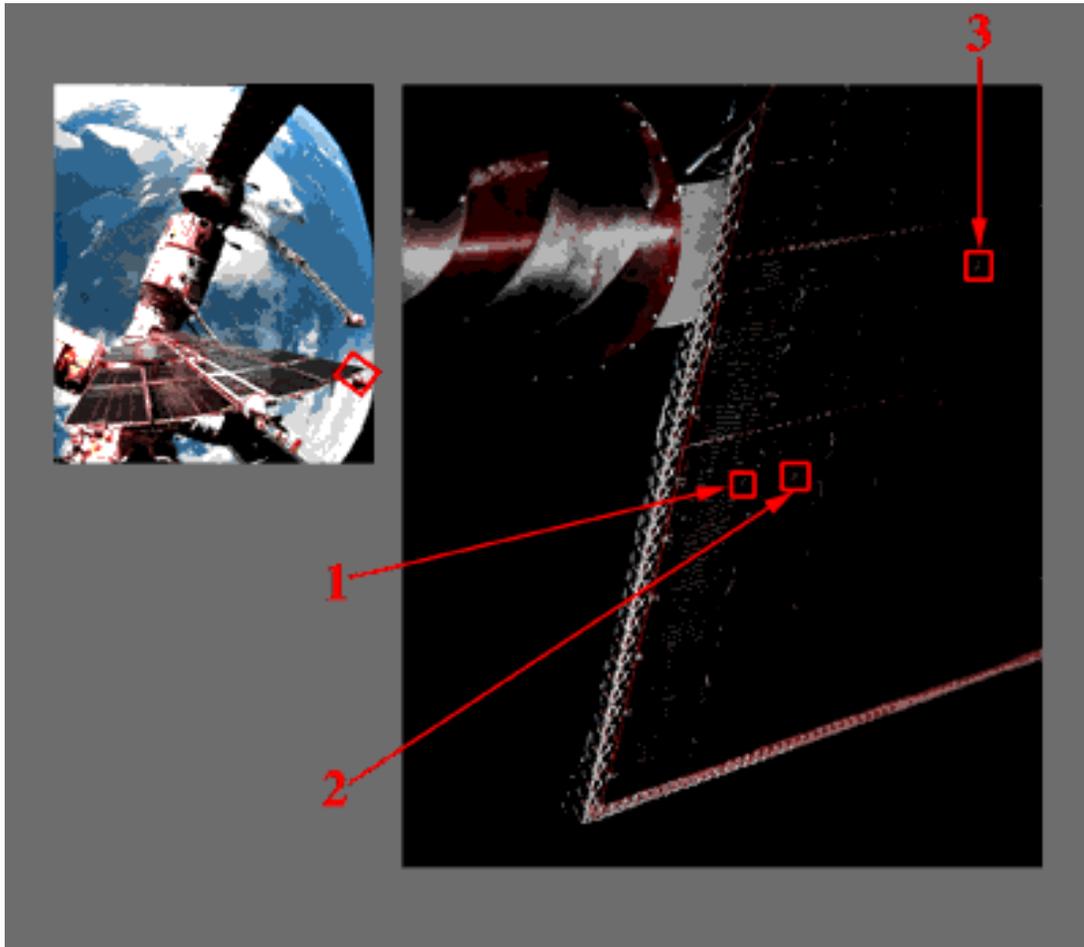
Figure 3-E SP#2 Base Block Array

- Measured the sizes of three possible micrometeoroid/debris impacts on Base Block SP#2.
- Observed no changes on the Mir Environmental Effects Payload (MEEP) panels.

Figure 3-E is an image of the SP#2 Base Block array showing three areas of potential micrometeoroid/orbital debris damage.

Areas 1 and 2 were estimated to be approximately 4 mm to 5 mm in diameter, while area 3 was approximately 6 mm to 7 mm in diameter. Orbital debris experts from the JSC Space Science Branch (SN3) concurred that these areas could be potential micrometeoroid/orbital debris damage. In order to estimate the sizes of the damage, data from an engineering drawing was used to scale the image. An intermediate image of the entire array was used to translate dimensions from the drawing to the detailed image shown here.

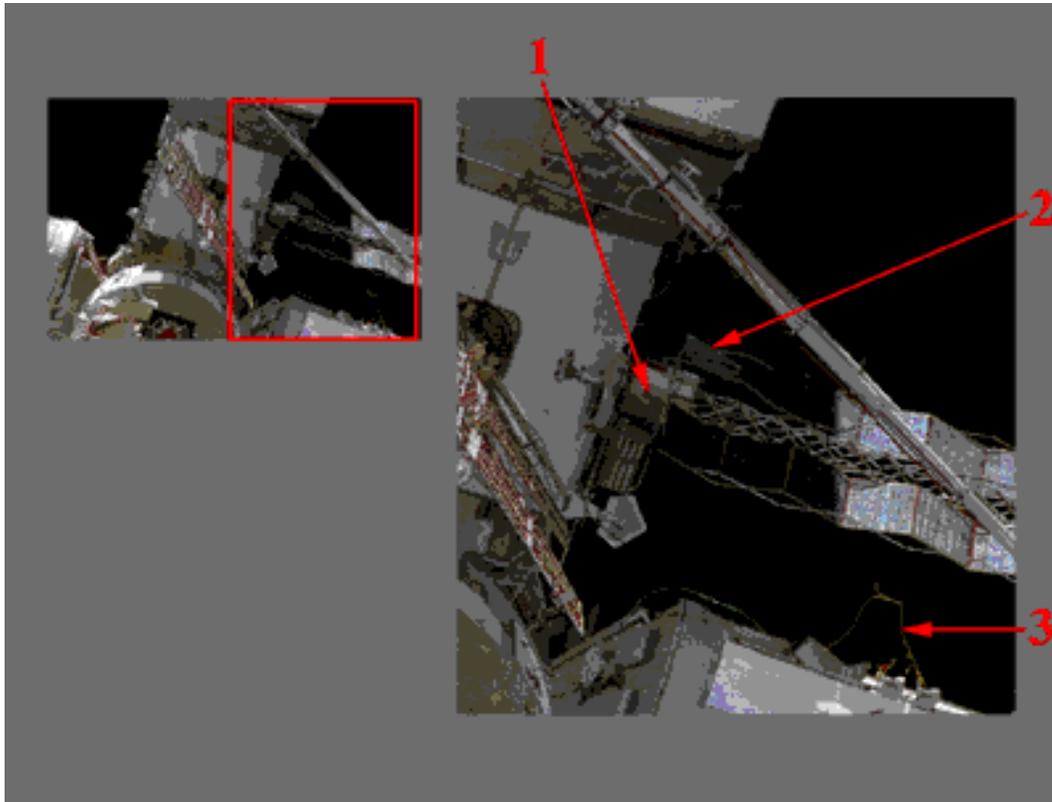
Figure 3-F SP#3 Base Block Array Attach

Item 1 points to brown discoloration around the base of the array. This appears similar in color to discoloration seen half way up the same solar array on STS-76.

Item 2 points to a region of the SP#3 array where a solar panel is missing near the array attach point on the Base Block. This missing panel was first photographed in detail on STS-74 and was measured to be approximately 60 x 75 cm.

Item 3 points to loose EVA tethers along the surface of Kvant-2.

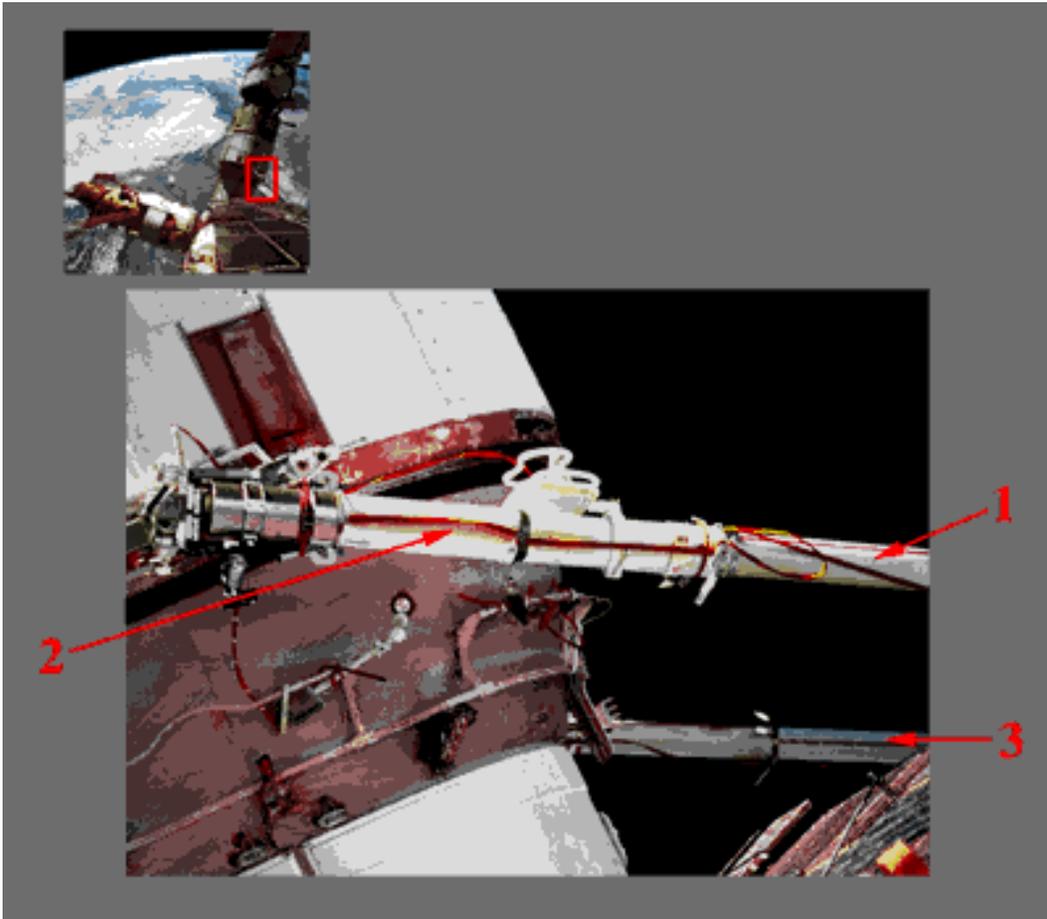
Figure 3-G EVA / Cargo Transfer Boom

Changes were observed in the surface condition of the EVA / Cargo Transfer Boom. The EVA / Cargo boom shows discoloration associated with the Kapton strap which is attached along the length of the boom. An increase was expected in the amount of chipped paint on the Spektr radiator, based on STS-74 and STS-76 results. There was no change in the amount of chipped paint, however extended areas of blistered paint were identified.

Item 1 points to the EVA / Cargo Transfer Boom which was mounted to the Base Block sometime after November 1995. Investigators are interested in the brown discoloration under the straps which run along the length of the boom. Item 2 points to this discoloration which appears to be caused by outgassing from the Kapton straps.

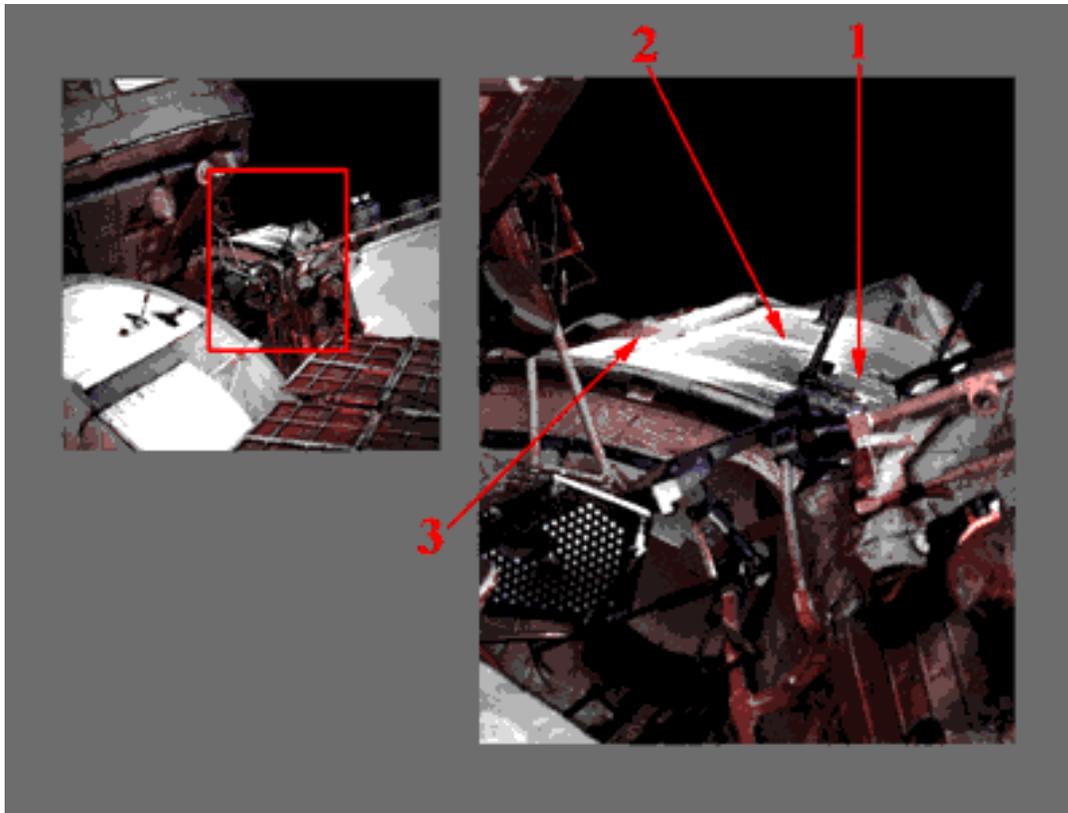
Figure 3-H Priroda Radiator Discoloration

Figure 3-H shows discoloration (Item 1) on the +XB, -YB radiator of Priroda. Priroda was deployed to Mir in April 1996.

Approximately three-quarters of the radiator surface has a dark gray deposition from an unknown source. Item 1 points to the area of darkest discoloration located on the lower +XB corner of the radiator. There is an uneven pattern to the deposition seen on the radiator. Some areas of the radiator appear to be their original whitish color, yet they are surrounded by areas of dark discoloration (Item 2).

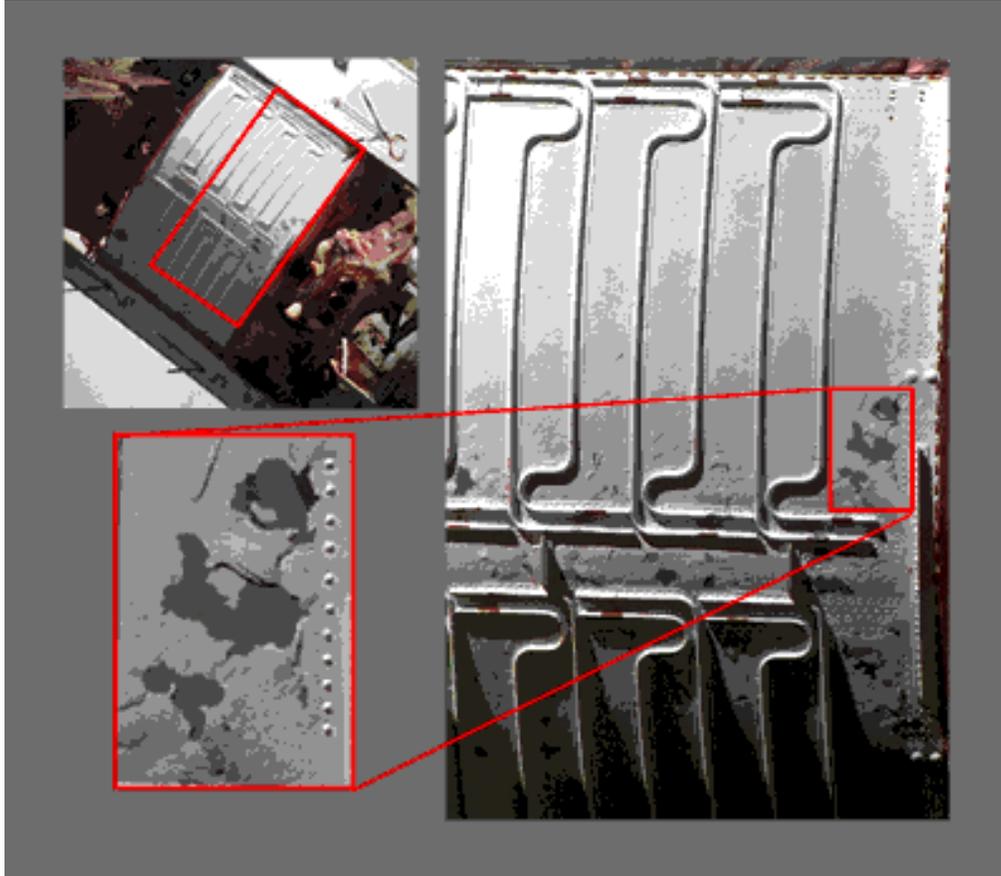
Figure 3-I Spektr Radiator

Figure 3-I shows the Spektr radiator as recorded with a 300 mm lens on the Nikon camera during STS-79. A comparison was made of the extent of chipped paint across three missions: STS-74, STS-76 and STS-79. The Spektr radiator has been the subject of attention since the STS-74 mission imagery showed several areas of chipped and blistering paint.

The STS-79 image identified close to 100 areas of chipped paint on the surface of the radiator. Although the amount of chipped paint increased by approximately 50% in the four months between STS-74 and STS-76, there was no significant change in the four months between STS-76 and STS-79. However, the STS-79 image revealed for the first time a large amount of blistered paint which appears ready to peel off the radiator.

An improved method was used for estimating the area of chipped paint. Results are decreased from earlier reports. In the earlier reports, the area of chipped paint was determined by thresholding the digitized image. Thresholding errors associated with lighting and shadowing variations resulted in estimates which favored larger area estimates. In the current approach, the analyst manually “blackened” the pixels observed as chipped paint before thresholding was applied. The results are 0.7% (550 cm²) for STS-74 and 1% (800 cm²) of the total radiator surface area for STS-76 and STS-79. The earlier estimates (JSC-27525, STS-76 Mission Report) were 1% (800 cm²) for STS-74 and 1.7% (1300 cm²) for STS-76.

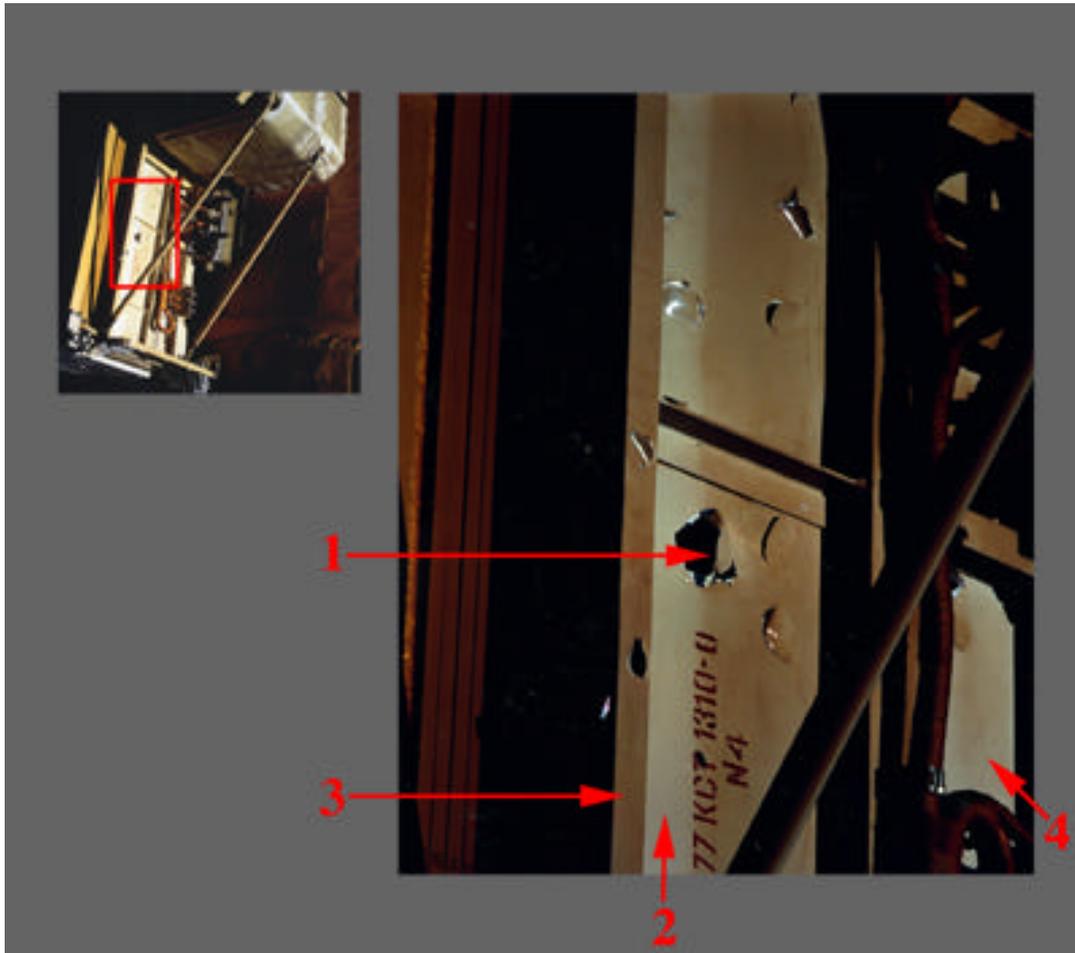
Figure 3-J Reusable Solar Array Carrier

- Found large areas of paint peeling off the Reusable Solar Array (RSA) carrier which may represent a safety concern.
- Identified new areas of discoloration attributed to outgassing or contamination on the Base Block and Cargo Transfer Boom.

Figure 3-J illustrates in detail the blistering paint and discoloration on the Reusable Solar Array (RSA) carrier mounted on the starboard side of the Docking Module.

The blistering paint and discoloration was first visible during STS-76, only 4 months after deployment of the Docking Module to Mir. The amount of damage appears to be approximately the same as that seen on STS-76. However, this image from STS-79 reveals detail not visible in STS-76 photography.

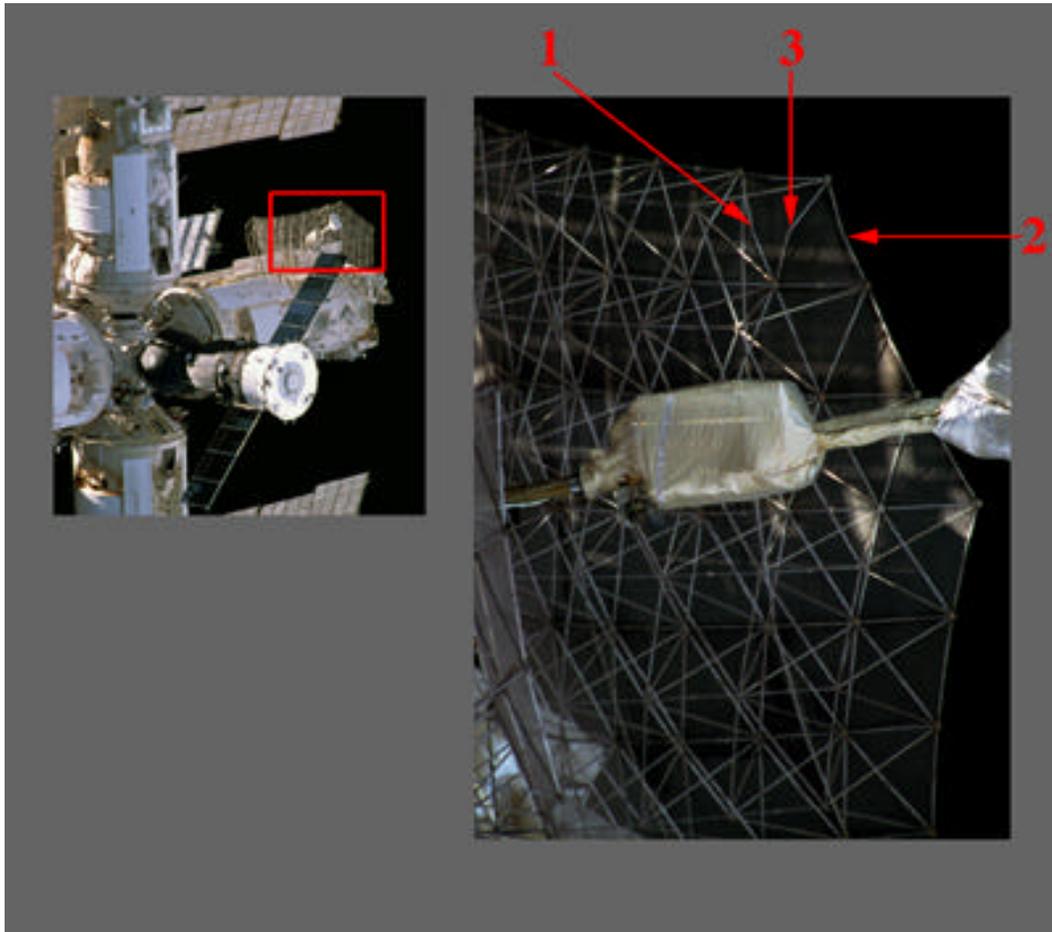
Figure 3-K Priroda SAR Antenna

The SAR antenna in the +YB corner has a visible asymmetry. Items 1, 2, and 3 point to spars which do not appear to be fully extended. The -YB corner appears to be fully extended. The three spars show inward bends which are estimated to be approximately 10, 20, and 30 degrees.

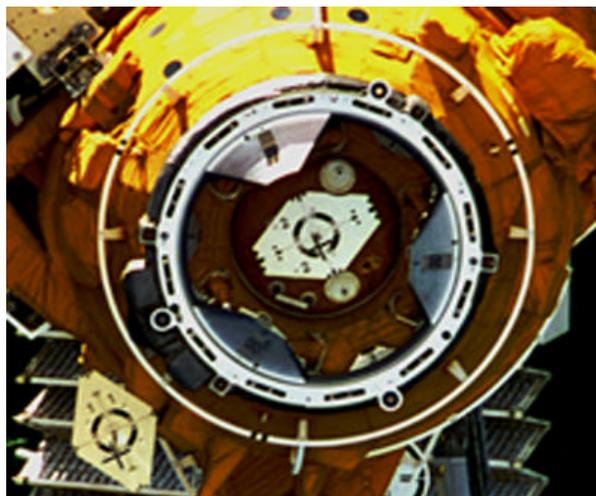
**Figure 4-A Docking Mechanism View from Station-keep
(Nikon with 300 mm Lens)**

During the Orbiter station-keep at 170 feet, two frames were taken of the Mir docking mechanism using the 35 mm camera with the 300 mm lens. Each frame was taken with bracketing exposures under good illumination conditions. The images were face-on views and show the docking mechanism to be in good condition and without discoloration as shown in Figure 4-A.

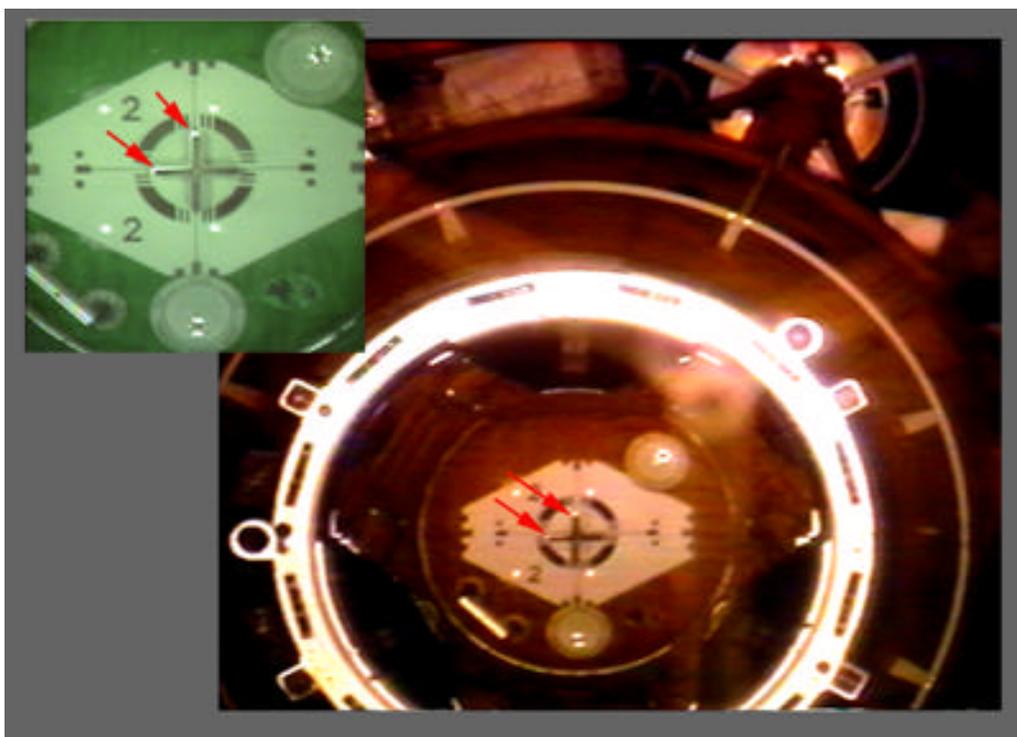
**Figure 4-B Centerline Image of Docking Mechanism Showing
Detached Laminate (Docking)**

Imagery surveys of the docking mechanism were performed to verify its condition. In addition, a target viewing assessment was conducted to evaluate the performance of video cameras used during the approach. Analyses of these views help in determination of camera usage for ISS proximity operations. The STS-79 crew discovered that the black laminate was partially detached on two of the stand-off target cross arms. During their stay at Mir, the crew repaired the stand-off target by taping the black laminate into its original position.

Between 170 feet and 15 feet, during approach, the Mir was in darkness. Although there are significant amounts of glare and other reflections, the ODS centerline camera shows the docking mechanism to be in good condition. The camera also reveals that the black laminate is partially detached on two of the stand-off target cross arms (see Figure 4-B). Non-axial video camera imagery taken just at the beginning of sunrise also shows the docking mechanism in good condition, however this image is less detailed than the 35 mm image.

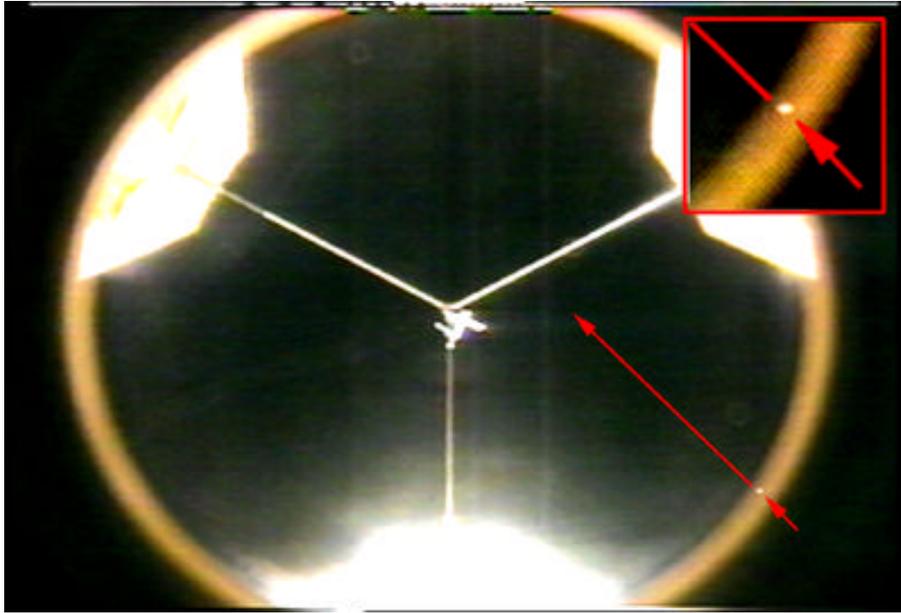
Figure 6-A Debris Originating from ODS

During Mir approach, several pieces of debris were observed which appeared to originate within the ODS. In one case, this was confirmed as shown in Figure 6-A. The debris is shown within the ODS by the centerline camera. Red arrows in the figure show the direction of the debris. From approximately GMT 263:02:32:00 to 263:02:35:00, a large amount of debris, probably ice, was seen from payload bay camera C during RCS attitude jet firings. The debris was probably more prominent because it was reflecting direct sunlight. From approximately 263:02:19 to 263:02:27, a bright object was observed from PLB camera A. The object moved very slowly; in fact, the motion was only noticeable during high speed playback.

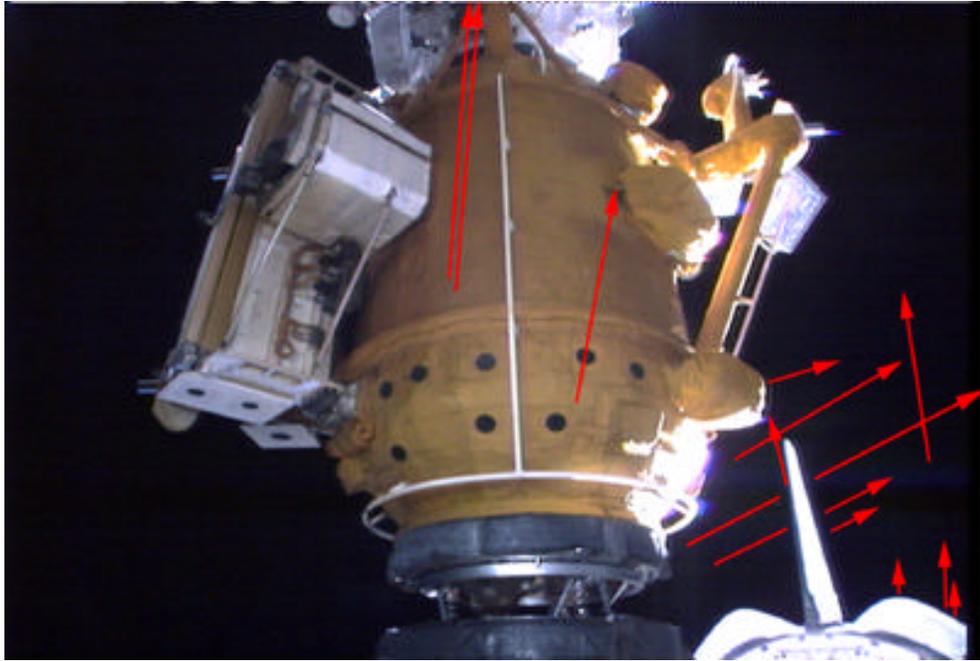
Figure 6-B Trajectories of Small Debris Observed After Soft Dock (Payload Bay Camera A)

During the transition from soft dock to hard dock, many pieces of small debris were observed. Thirteen pieces of small debris, observed with camera A after the time of soft dock, were tracked as shown in Figure 6-B. These debris, probably ice, condensate, or propellant molecules, appear to have originated from three different areas. These areas are the payload bay, the ODS / Docking Module interface, and from the Orbiter thrusters. However no piece of debris was visually observed from its origin. Three pieces traversed in the line of sight between the camera and the Mir Docking Module in an Orbiter +Z direction from the Orbiter payload bay and toward the Station. Four other pieces traversed in a parallel path, but not in the line of sight, between the camera and the Docking Module. Five pieces of debris traversed paths approximately 45 degrees diagonal to the Orbiter Y-Z plane in the -Y, +Z, direction.

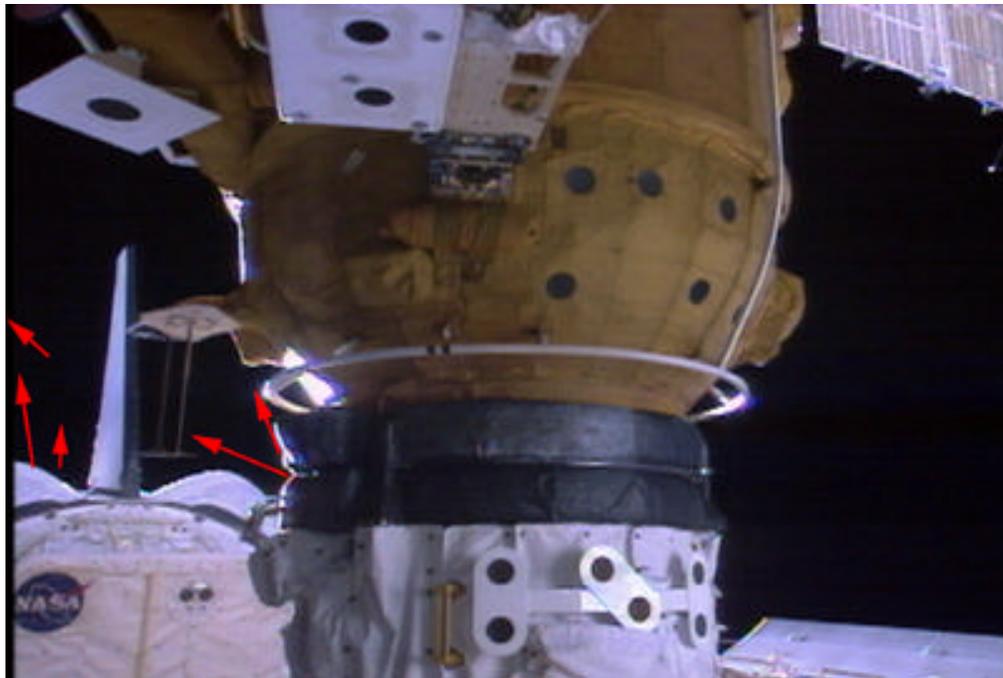
Figure 6-C Trajectories of Small Debris Observed After Hard Dock (Payload Bay Camera D)

Video was switched from camera A to camera D just prior to hard dock. Just after hard dock, when the sun's rays reached the docking interface, five pieces of debris were observed (see Figure 6-C). One piece of debris was observed to originate from the interface of the ODS and the Docking Module. It traversed a direction perpendicular to the ODS / Docking Module axis, and in a +Y direction.

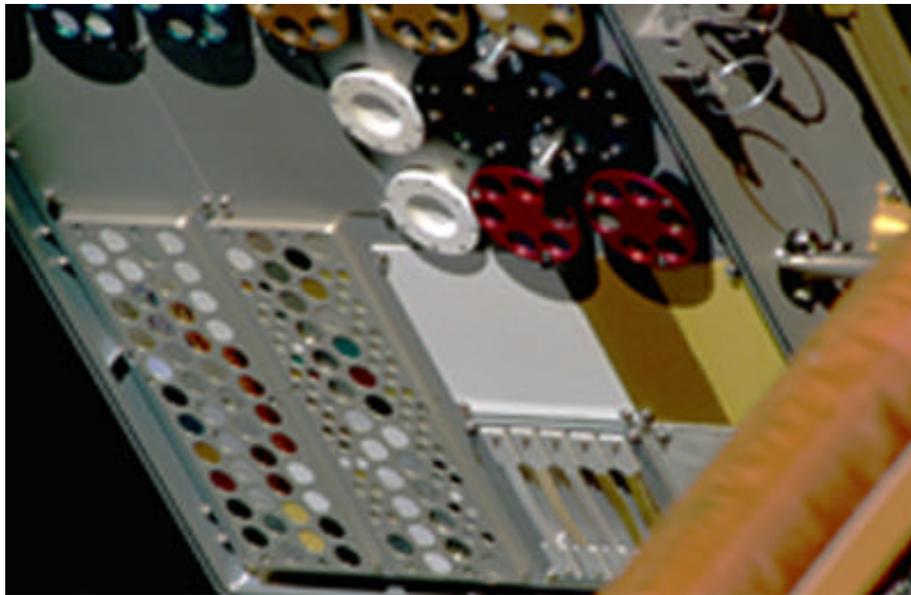
Figure 7-B Image of POSA taken with Nikon and 300 mm Lens from Aft Flight Deck Window (Shuttle Docked)

Still photography was taken of POSA from the Shuttle aft flight deck window with the Nikon 35 mm camera and the 300 mm lens while the Shuttle was docked to Mir. This image was of high resolution and fidelity and showed no damage or discoloration of POSA.
